HIGHLAND LAKE, MAINE
FALMOUTH, WESTBROOK,
WINDHAM

**2018 Highland Lake
Watershed Survey
March 2019 ~ Highland Lake Association**

Prepared by
Watershed Survey Steering Committee
Highland Lake Association

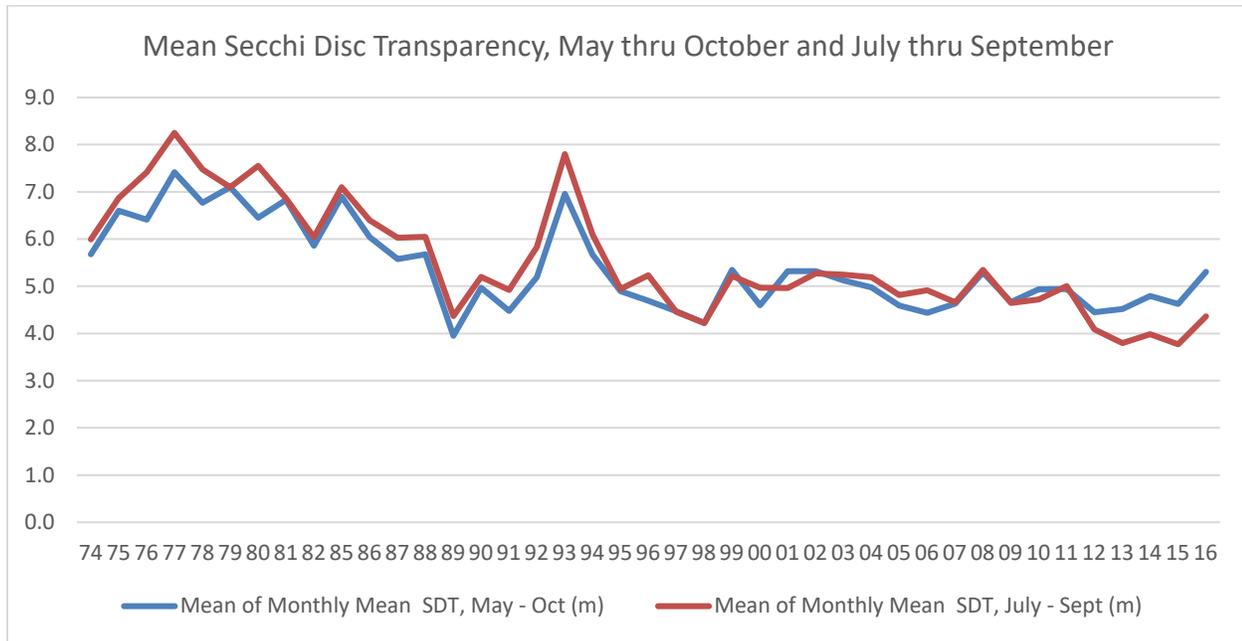
Figure 2. Mean of Monthly Mean SDT in meters from 1974 to 2016¹.

A change in seasonal succession is also reflected in **Figures 2 and 3**. In **Figure 2**, the blue line represents average SDT for the period of May through October in each year. The red line represents average SDT for July through September. When the red line is above the blue line, it indicates that the clearest water with the least algae is occurring during the summer months. Conversely, when the blue line is on top, the less clear

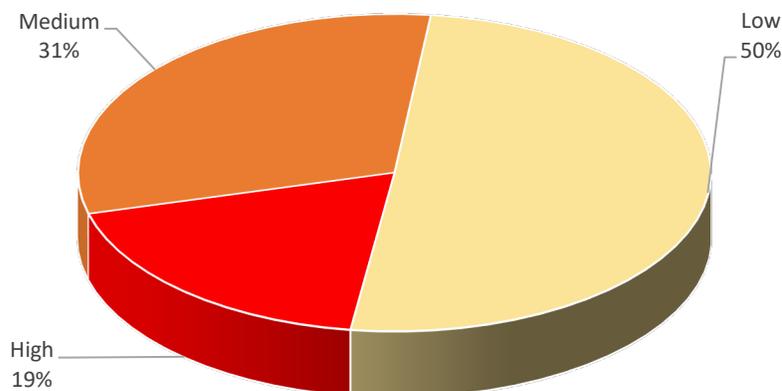
FIGURE 5: IMPACT RATING BY PERCENT FOR ALL SECTORS

Of these, 65 sites were rated as low impact, 40 sites as medium impact, and 24 sites as high impact. Overall, approximately 50% of the sites found were rated high or medium impact. **Table 2** presents impact data for each survey sector and **Figure 5** displays the percentage of each impact rating across all sectors.

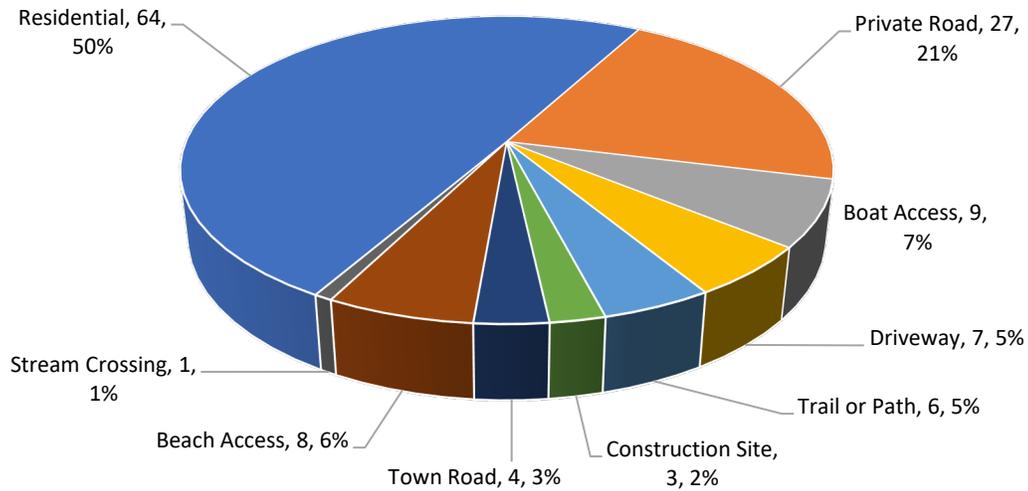
FIGURE 6: NUMBER AND PERCENTAGE OF SITES BY LAND USE

As shown in **Figures 6 and 7**, the residential and private road land use categories make up the vast majority of NPS sites identified during the survey. Between them, they also have the most sites in each impact rating (high, medium, and low) as compared to the other land use categories. Because they are the predominate land use categories, and to simplify analysis of land use data, other land use categories that are closely aligned with residential and private roads have been grouped together to create the “Residential Group” and the “Road Group”. Since the boat access, trail or path (all right-of-ways to the lake), and construction site land use categories don’t align with either the Residential Group or the Road Group, they are treated as the “Miscellaneous Group”. The three groups and their respective land use categories are presented in **Table 3**, followed by an analysis of each.

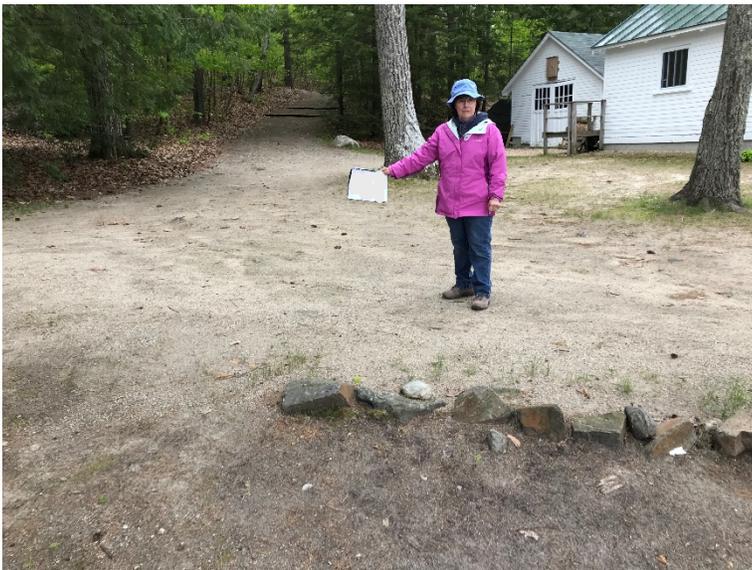
Residential

This site is representative of several residential group land uses where the combined runoff from each has caused significant sheet erosion in the yard and along the shoreline. Runoff from the lower driveway combined with runoff from the roof and compacted bare soil in the yard is discharging sediment directly into the lake. In addition, without a delineated and stable path for beach access, vegetation is unable to take root and stabilize the shoreline.

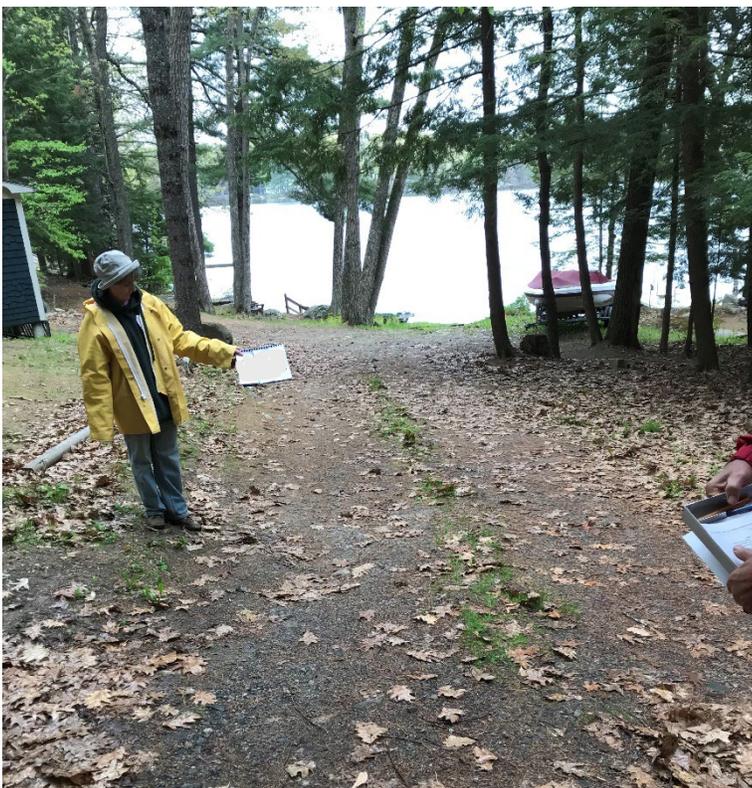
Driveways

This site is representative of typical driveway problems that can occur when runoff flows directly down the driveway, gaining in both velocity and volume as it nears the lake. These two factors combine to erode the driveway surface material and the resulting sediment is deposited into the lake. Because driveways see light vehicular use relative to roads, runoff diverters can be placed across driveways at intervals, breaking up the flow of water and sediment and depositing it into adjacent wooded areas rather than the lake.

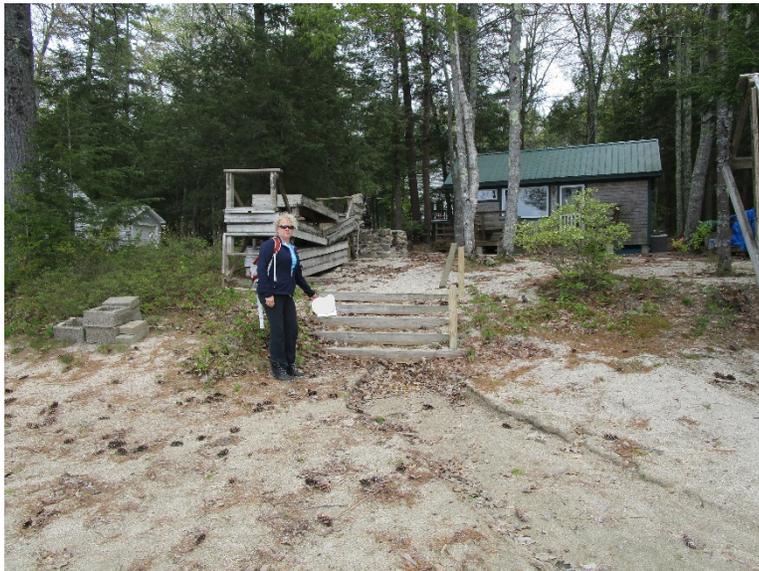
Beach Access

This site is representative of problems that can occur when runoff from upper areas of a lot is allowed to flow unimpeded to the beach. Beaches are very susceptible to erosion as is apparent by the severe rill erosion that can be seen below the steps. To protect the beach from erosion, runoff from the upper lot area must be diverted into a vegetated buffer that can slow and infiltrate runoff. In the absence of an adequate buffer, infiltration practices can be constructed to collect and infiltrate runoff.

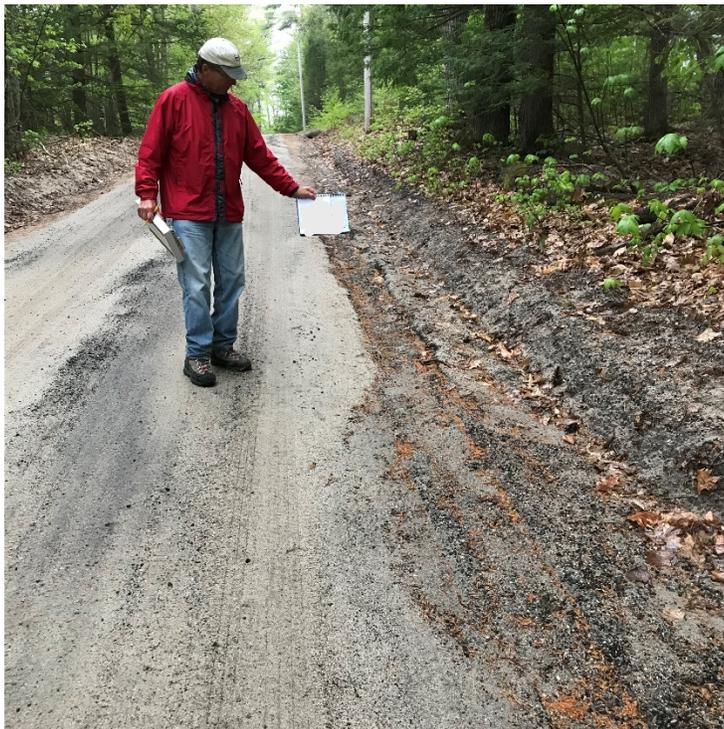
Private Road

This site is representative of several private road problems observed around the lake. Sheet flow from the road surface concentrates along the edge of the road and, in the absence of a stable drainageway, runoff is cutting into the road shoulder producing rill and gully erosion. Winter sand that has accumulated on the road surface and the road bank is washed down to the bottom of the hill by the force of the flowing water. Because the road is sunken relative to the surrounding landscape, there is also no place to divert or “turnout” the water into the adjacent wooded area.

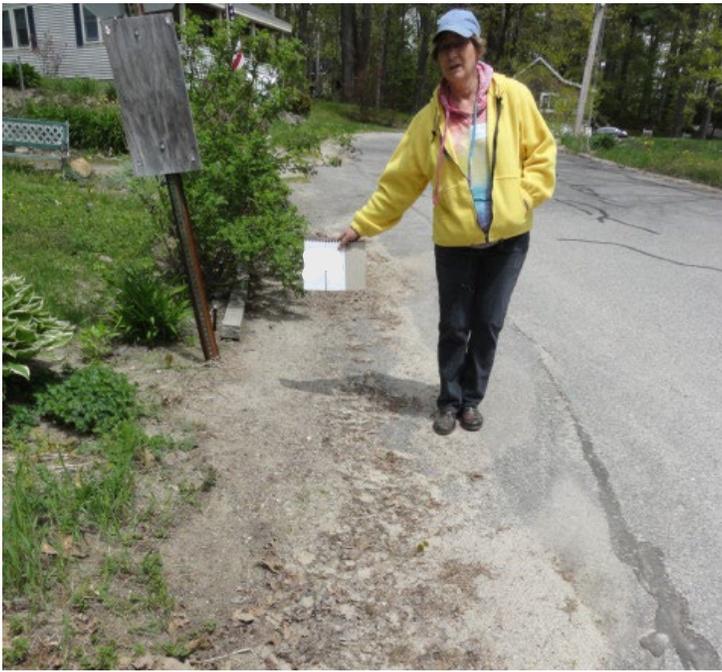
Town Road

This site is representative of some of the problems observed along town roads. Although town roads where problems were observed are paved and therefore resistant to erosion, the ditches running alongside the roads are very susceptible to erosion if they aren't vegetated or lined with stone. Also, ditches along town roads can fill with winter sand (shown here) as they do along private roads, potentially resulting in erosion problems downstream. Ongoing ditch maintenance is key to preventing these types of problems.

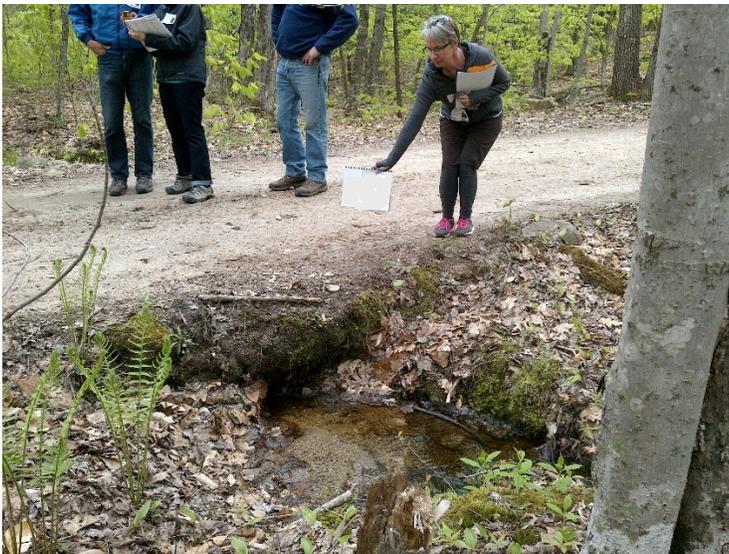
Stream Crossing

This site is representative of the problems that can occur where roads cross over streams. Runoff from roads can erode slopes around culvert inlets and outlets if they are not stabilized with stone and/or vegetation, particularly if the stream crossing is at a low point in the road. Also, as more road material gets pushed to the edge of roads, the culverts can become clogged. The velocity of water flowing through a culvert can also lead to erosion of stream bottoms and banks.

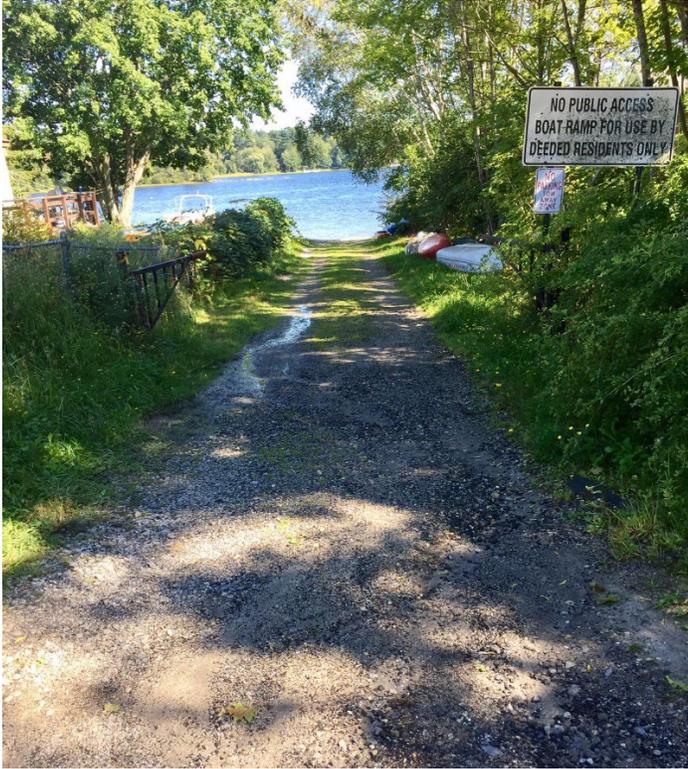
Boat Access

This site is representative of boat access problems caused by runoff flowing straight toward the lake over a loose aggregate surface. Flow is concentrated in wheel ruts created by heavy vehicular and trailer traffic. By the end of the ramp, the volume and velocity of the flow is often enough to wash out the end of the ramp. Large quantities of sediment enter the lake this way as evidenced by the deltas that sometimes extend into the lake from boat ramps. Similar to problems on many private roads, there is no ditch or areas where the water can get off the ramp and into vegetation bordering the ramp.

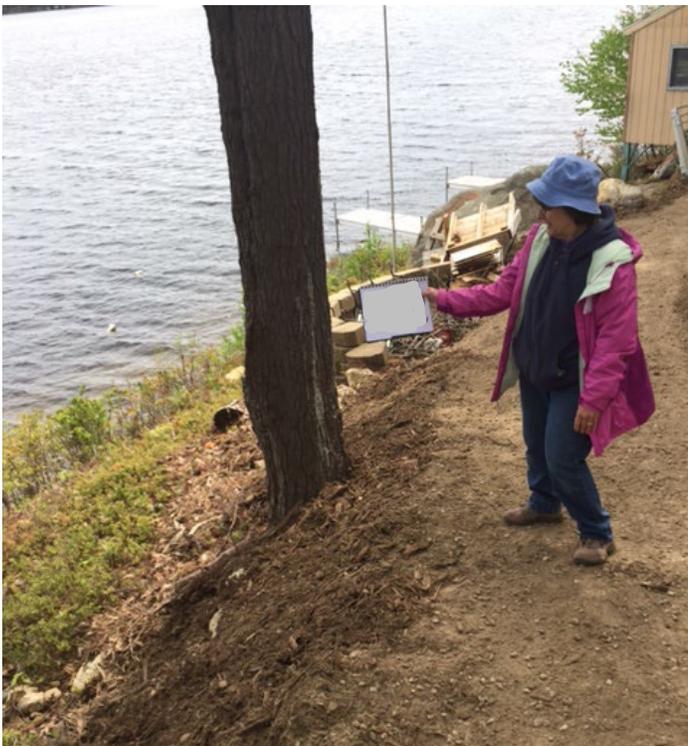
Construction Site

This site is representative of construction sites where the absence of a sediment barrier such as silt fence or an erosion control mix berm could potentially lead to direct discharge of sediment into the lake. Prior to construction, erosion control plans must be prepared and approved by the towns and erosion and sedimentation controls installed. Contractors must maintain the controls over the course of construction to ensure they remain effective. Under the Erosion and Sediment Control Law, landowners and/or contractors could potentially be fined for failing to comply with requirements of the law.

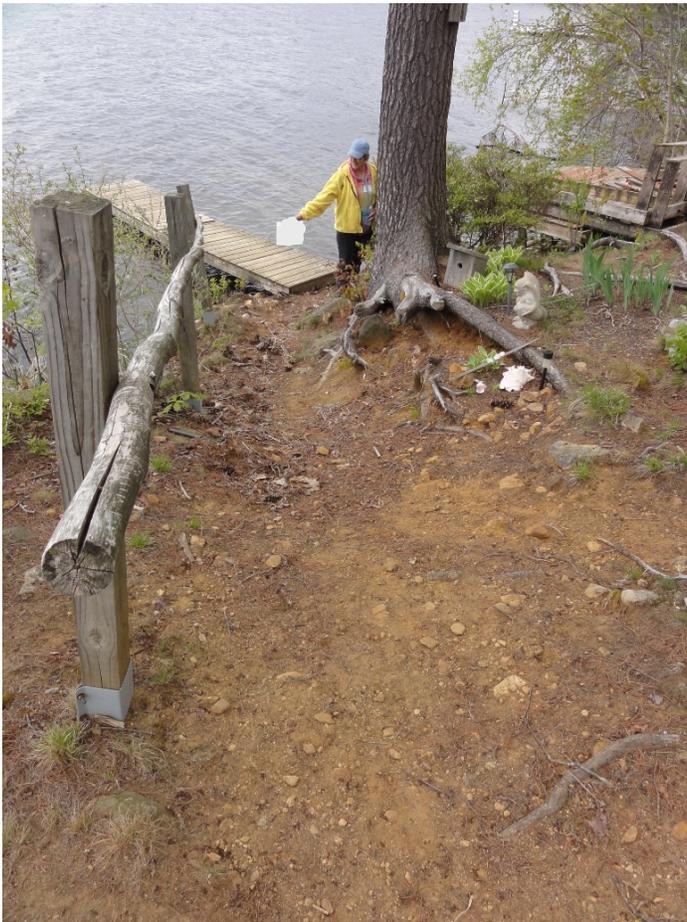
Trail or Path

This site is representative of problems with trails or paths that typically lead to the lake. The combination of a steep bank, bare soil, and no vegetated buffer for runoff to be disbursed results in a chronic erosion problem. Non-Residential Group trails or paths with problems identified during the survey are used by several landowners with deeded access, consequently, the amount of foot traffic is higher and the damage greater than on paths used by individual homeowners. Practices to protect the ground and surrounding vegetation must be installed to protect the slope and allow runoff to infiltrate before it reaches the lake.

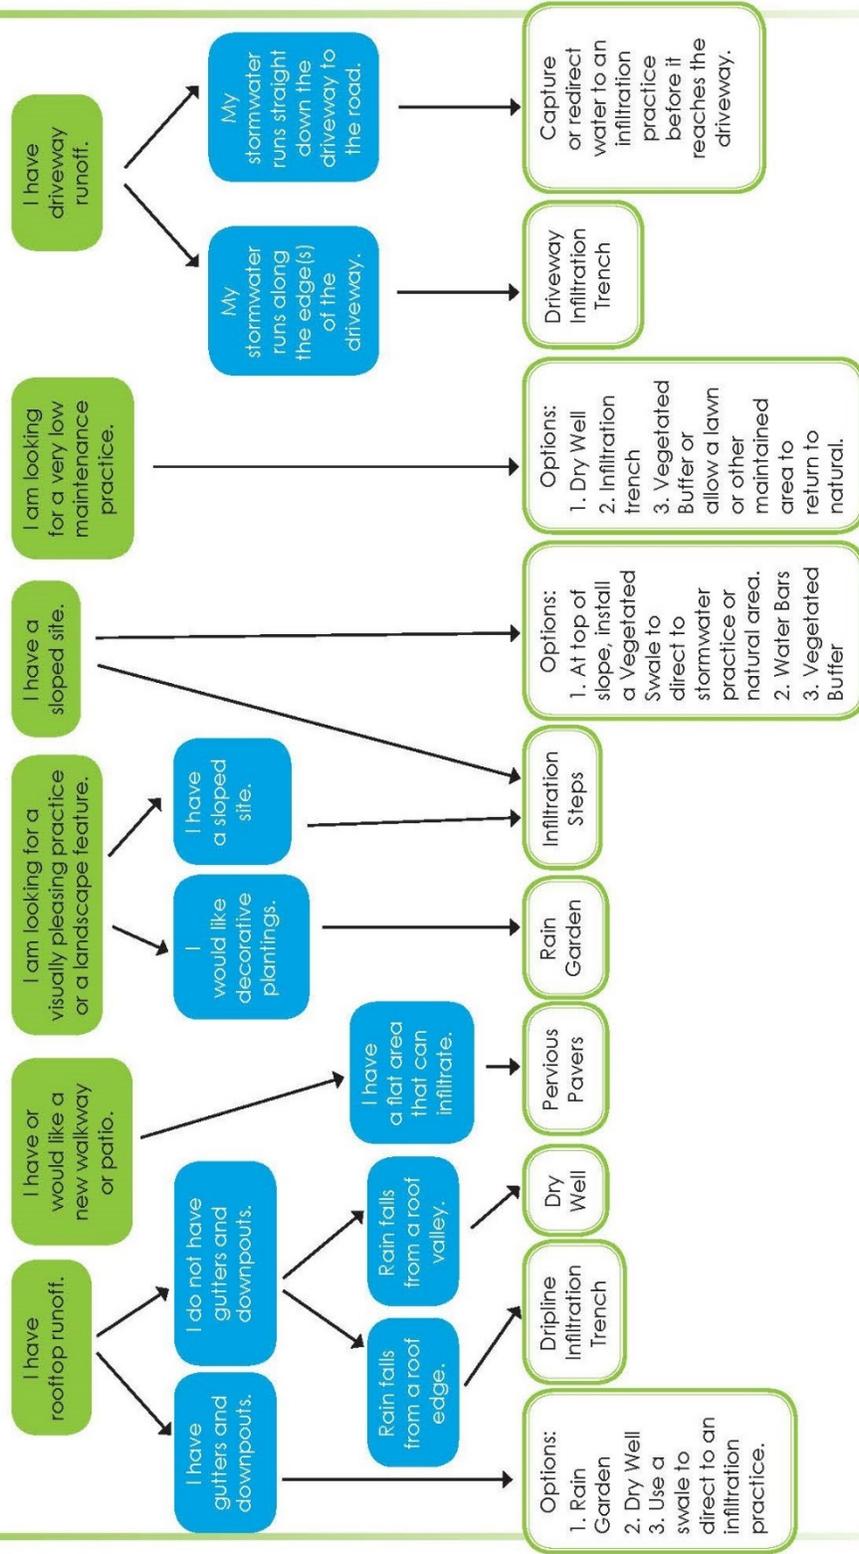
FIGURE 8: Infiltration Best Management Practices Flowchart

The flowcharts in **Figures 8 and 9** were copied from the New Hampshire Guide and can be used to assist homeowner's with BMP selection. **Figure 8** shows a flowchart for selecting infiltration BMPs and **Figure 9** shows a flowchart for selecting storage and conveyance BMPs.

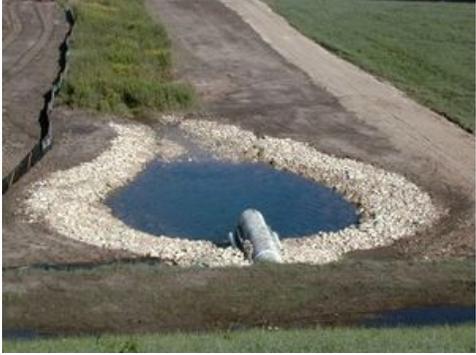
<p>Install Plunge Pool</p>	<p>Plunge pools are installed where there is a need to dissipate the flow of high velocity water exiting a culvert in order to prevent channel erosion at the culvert outlet. They are typically armored with stone. Plunge pools should NOT be installed in a stream channel without first obtaining a permit.</p>
